RADIO KEYLINE MODIFICATION

SCOPE: This modification applies to all Sigtronics intercom (SPA-, SDB-, SCI-, Sport-) installations that will utilize both pilot and co-pilot transmit positions. See alternate solution if using pilot only transmit position.

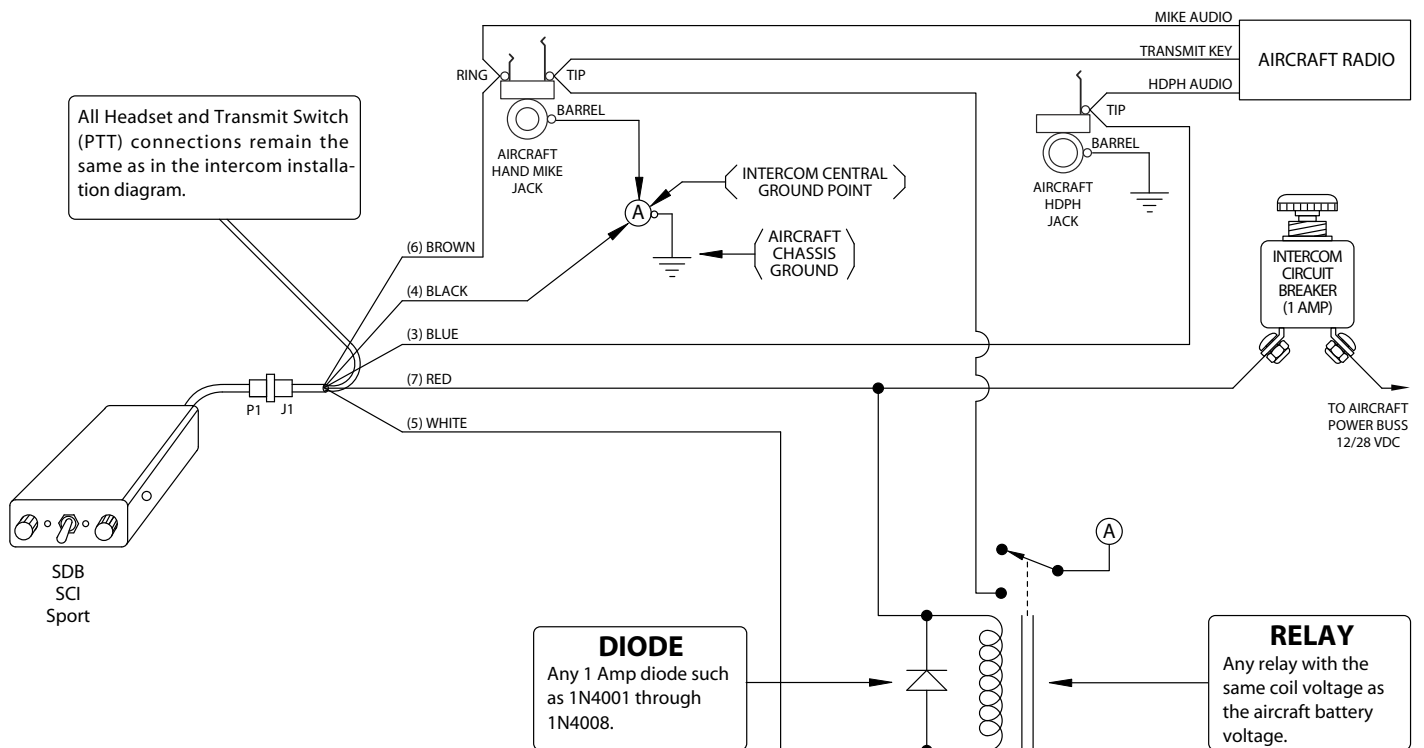
PROBLEM: The radio will not key up when either pilot or co-pilot PTT is pressed. This is due to the 0.7 volt diode drop within the intercom. Common installations affected usually involve KMA-20 audio panels or ICOM A220 radios.

VERIFICATION: Check to make sure all wiring and terminal connections are correct and unbroken. The radio will key up from the aircraft hand mike. Shorting the white wire (pin 5) to ground will key up the aircraft radio. The radio will not key from either PTT position. Shorting the white / red (pin 2) or the white / blue (pin 10) will not key the aircraft radio.

SOLUTION: A relay can be added to the installation that will eliminate the 0.7 volt diode drop. Follow the wiring diagram below.

Alternate Solution: For pilot only transmit installations. The pilot's PTT switch can be directly tied to the tip terminal of the aircraft hand mike jack. The PTT switch will still be connected to the white / red (pin 2) wire. The white (pin 5) wire will still be connected to the tip terminal of the hand mike jack.
