# RADIO KEYLINE MODIFICATION

**SCOPE:** This modification applies to all Sigtronics intercom (SPA-, SDB-, SCI-, Sport-) installations that will utilize both pilot and co-pilot transmit positions. See alternate solution if using pilot only transmit position.

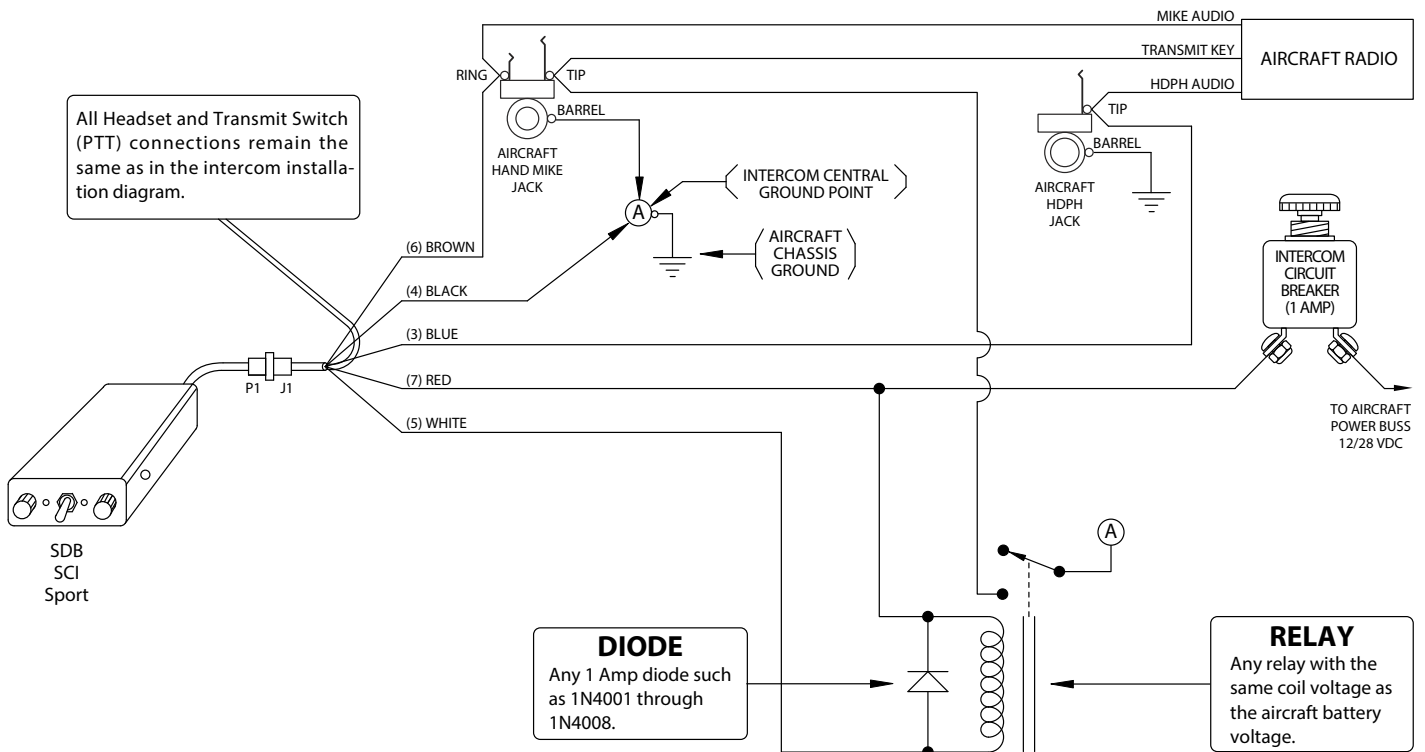
**PROBLEM:** The radio will not key up when either pilot or co-pilot PTT is pressed. This is due to the 0.7 volt diode drop within the intercom. Common installations affected usually involve KMA-20 audio panels or ICOM A220 radios.

**VERIFICATION:** Check to make sure all wiring and terminal connections are correct and unbroken. The radio will key up from the aircraft hand mike. Shorting the white wire (pin 5) to ground will key up the aircraft radio. The radio will not key from either PTT position. Shorting the white / red (pin 2) or the white / blue (pin 10) will not key the aircraft radio.

**SOLUTION:** A relay can be added to the installation that will eliminate the 0.7 volt diode drop. Follow the wiring diagram below.
