SPA-400 / 600 EXTERNAL MIC INTERRUPT MODIFICATION

SCOPE: This modification applies to a Sigtronics SPA-400/600 or ST-400/600 installations.

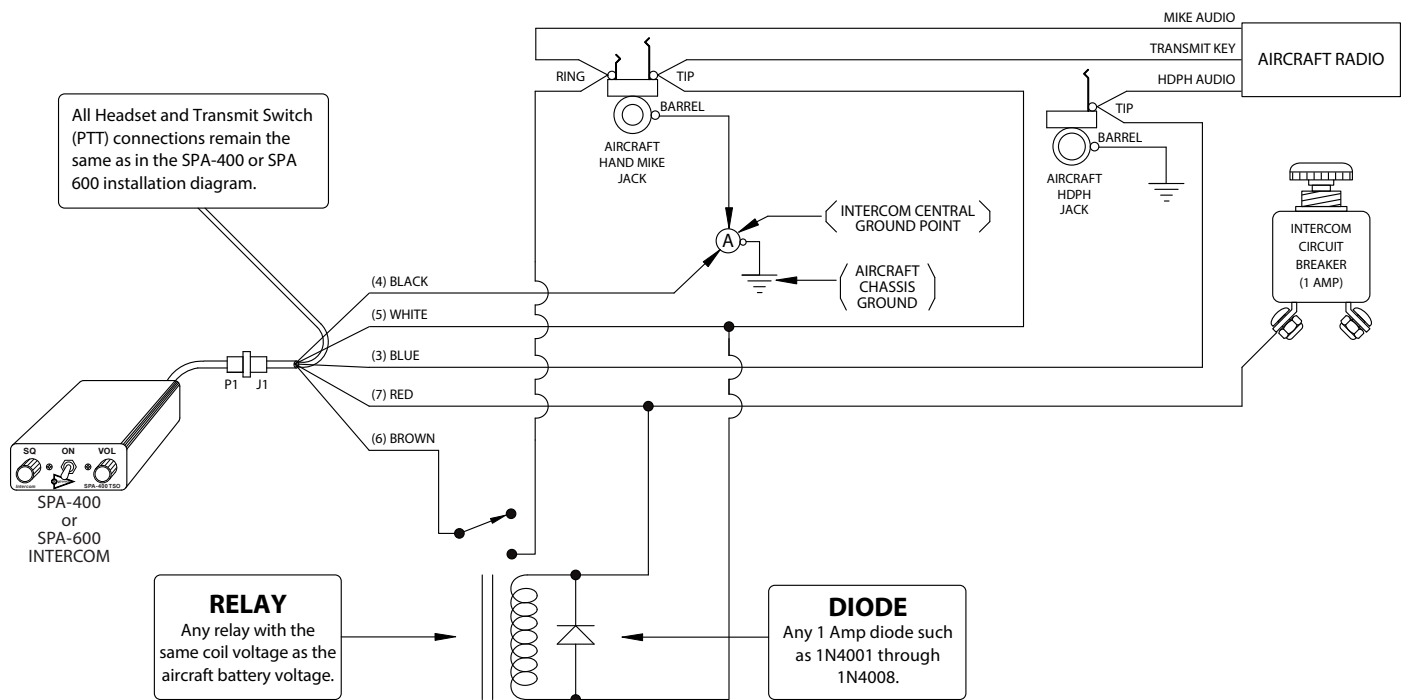
PROBLEM: The intercom stays hot or stays live all the time no matter what position the intercom squelch is set to. Most common with Terra radio equipment, King KY-92 radios, and a few others.

VERIFICATION: Turn off or disconnect the aircraft radio(s) from the intercom. If the intercom squelch now works - the radio(s) are bypassing the intercom and providing a "HOT MIC" type intercom.

1. Pull out the SPA-400/600 unit and send into Sigtronics for an internal modification. Request a "MIC INTERRUPT MODIFICATION". There is a modest fee for this.
2. If time does not allow this, a small relay can be added to the installation that will accomplish the same thing. Follow the wiring schematic below.
